Inspection Report

Minerals Regulatory Program

Mine Name: Black Shale/Rose Mine	Permit Number: M/049/0084	Permit Fees: Paid		
Operator Name: Interstate Brick Co.	Inspection Date: 08/06/2013	Bond Amount: \$25,000.00		
Inspector(s): A. Abate, J. Hewitt, Frankie	Time: 11:00 AM	Bond Escalation: due \$182,000		
Others:	Mine Status: Proposed			
Elements of Inspection		Evaluated	Comment	Enforcement

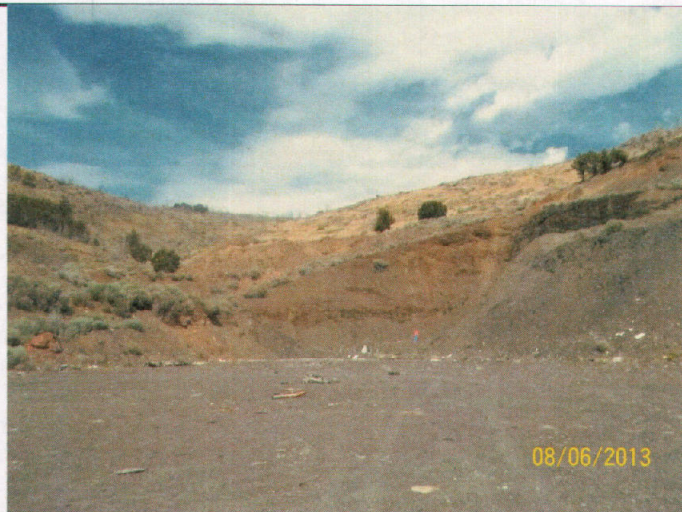
Entry into the Black Shale Mine. A considerable amount of debris was noted in the pit.

In accordance with rule R647-4-107.1.14, the operator should install a gate where public access to the site is readily available.

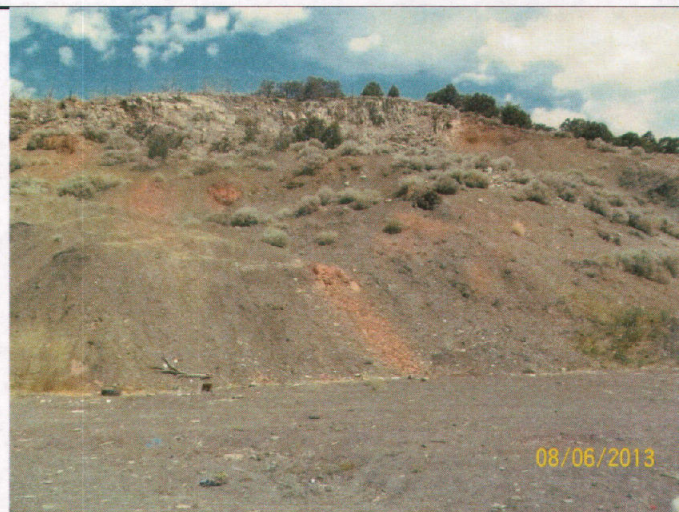
The rocky outcrop area on the top of the hill is the pre-law area where mining initially took place.

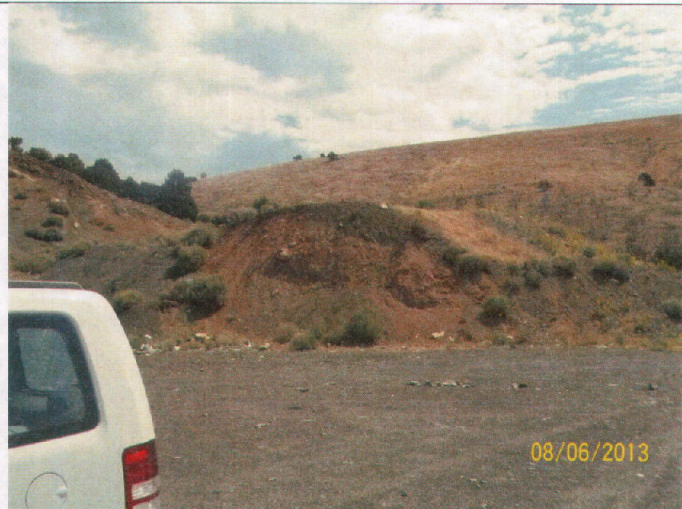
One of the topsoil piles salvaged at the base of the pit.

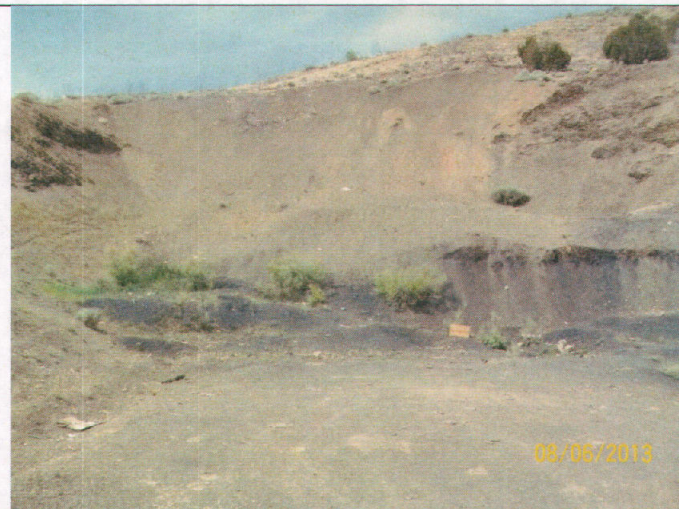
Highwall of pit that will be mined. Tamerisk in the background is the location of the groundwater seep.

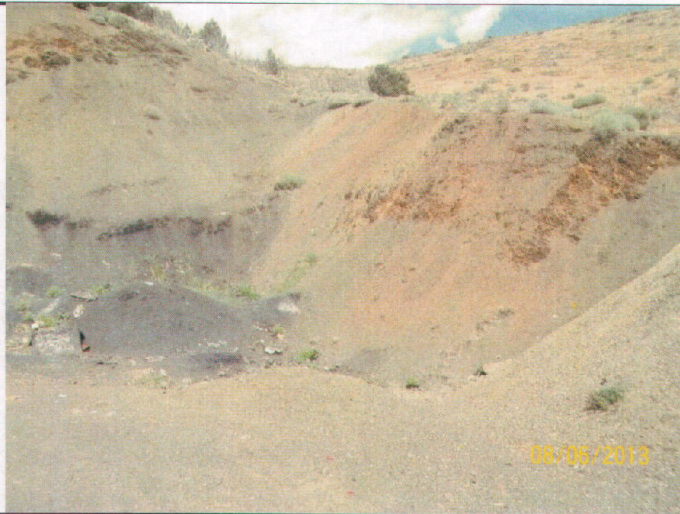
The dark material at the base of the pit is normally flooded due to the seep originating from the highwall.

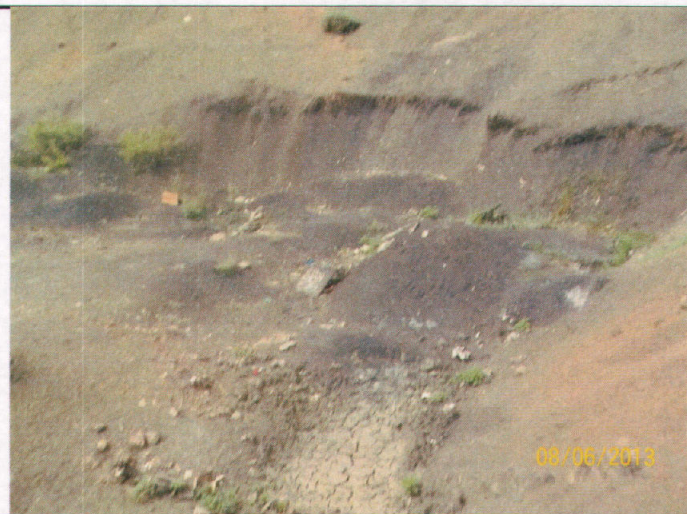
Evidence of flooding based on the mudcracks. The operator plans to retain this feature as a pond to promote wildlife habitat.

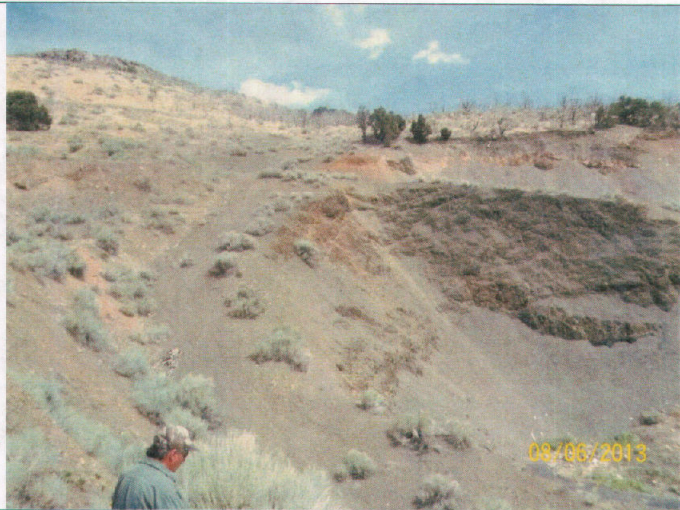
Topsoil pile to the left of the photo.

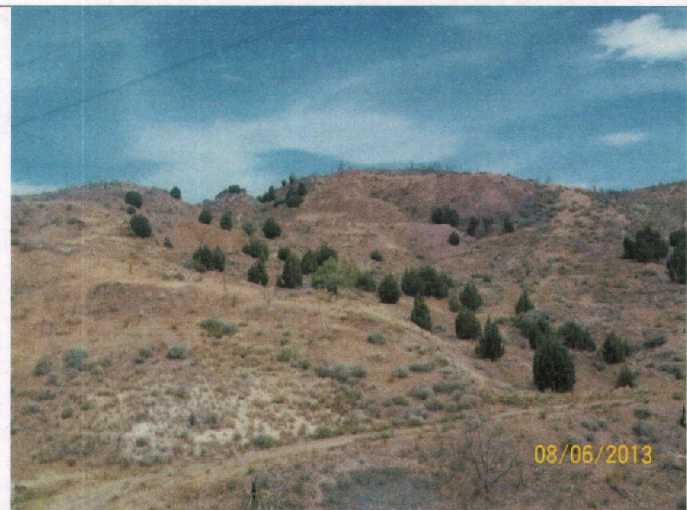
View of the Rose mine on the other side of the ridge. The operator plans to mine this concurrently with the Black Shale mine.
